SCOUR PROTECTION FOR PIKE ISLAND DAM, OHIO RIVER

Hydraulic Model Investigation

Final Report

Prepared for US Army Engineer District, Pittsburgh
Pittsburgh, Pennsylvania 15222-4186

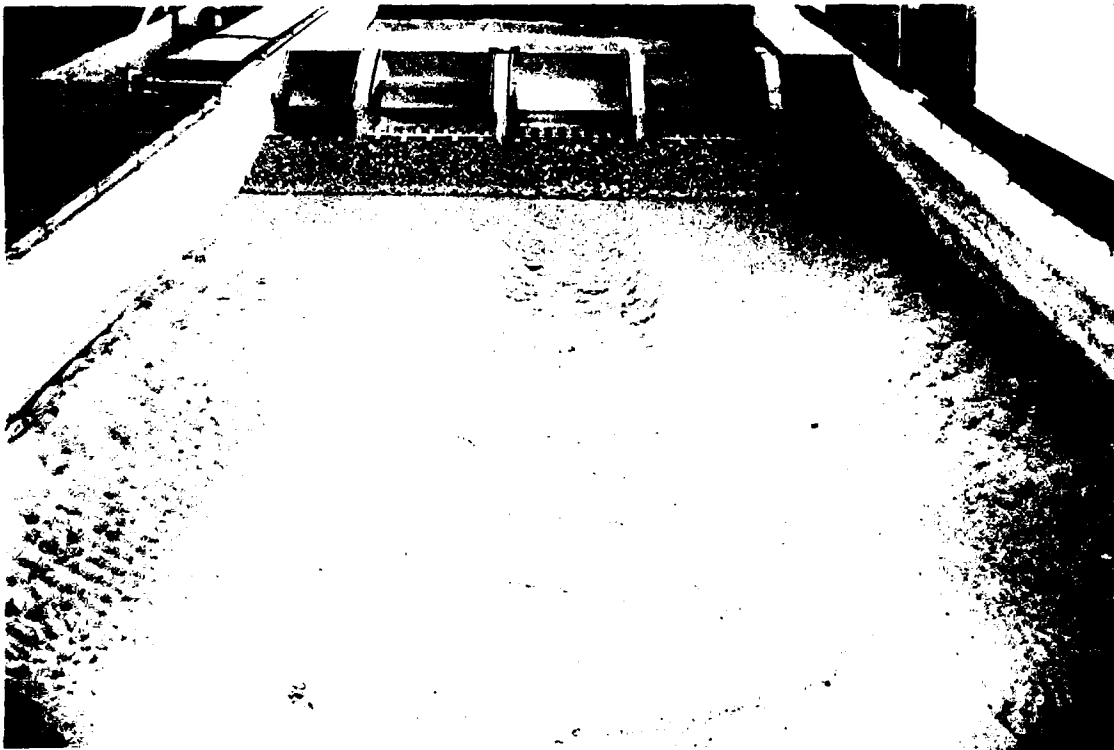
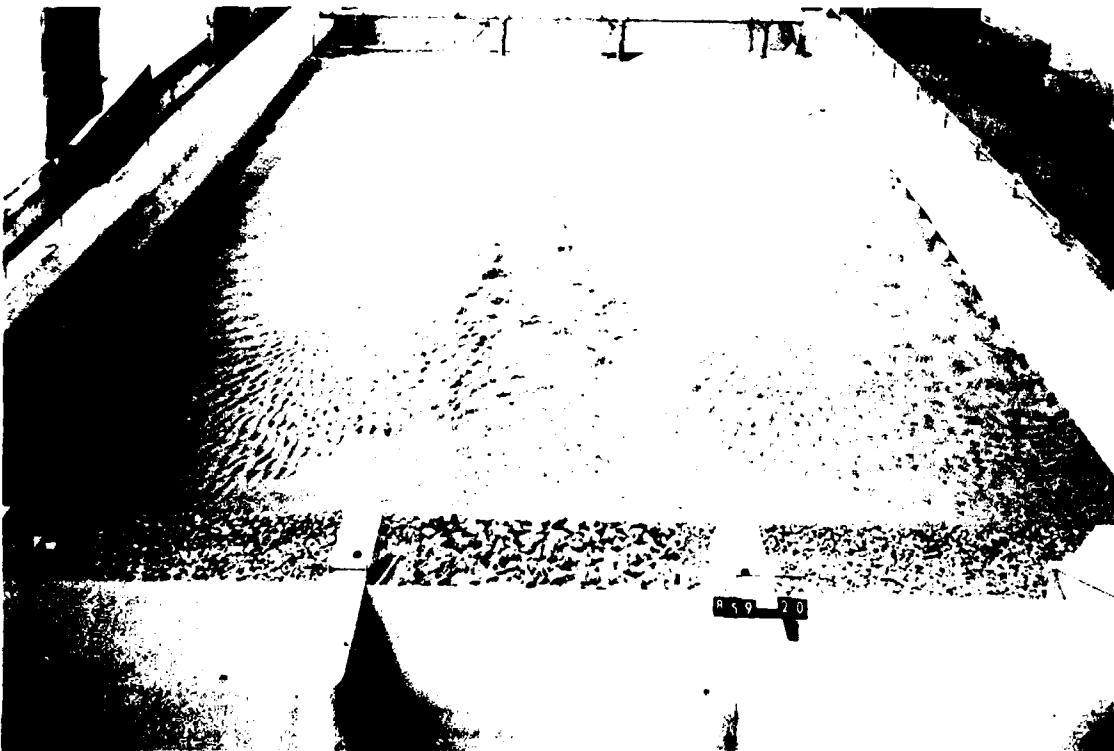
16. Flow conditions with the minimum tailwater elevation (634) where the type 2 riprap plan remained stable with uncontrolled flow through one gate bay are shown in Photo 4. Photographs of the scour in the exit channel after 5 hours (prototype) of operation with these conditions are shown in Photo 5 and a center-line scour profile is shown in Plate 17. Although the type 2 riprap plan was considered stable with uncontrolled flow and a tailwater elevation of 634, this operation should be avoided, if possible, due to the extreme amount of turbulence observed. Uncontrolled flow with a normal tailwater, el 643.3, is shown in Photo 6 for comparison of turbulence with the two flow conditions.

Photo 5. View of scour in exit channel after 5 hr of operation
with pool el 644, tailwater el 634, and uncontrolled flow
